Urgent medical device advisory
Field Safety Notice

October 2025

Subject: Field Safety Notice – Update to December 2024 and August 2025 Field Safety Notices *(Boston Scientific Field Action Reference: 97125289F-FA)*

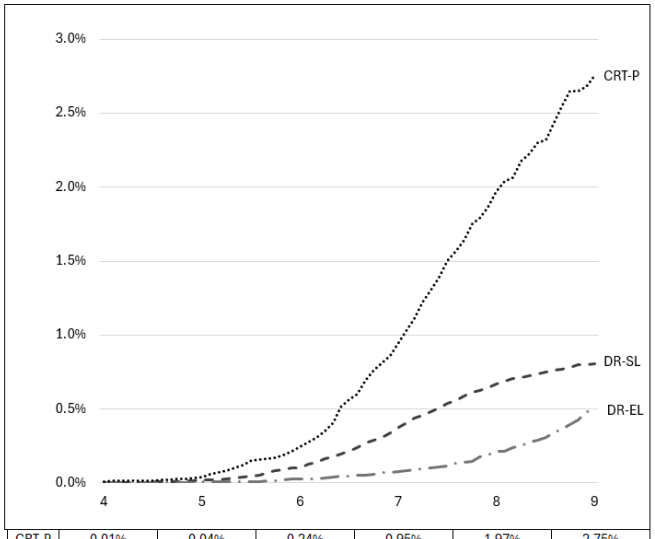
CRT-P	0.01%	0.04%	0.24%	0.95%	1.97%	2.75%
DR-SL	0.00%	0.02%	0.11%	0.38%	0.67%	0.80%
DR-EL	0.00%	0.01%	0.02%	0.08%	0.21%	0.49%

Figure 1 Occurrence rates for high battery impedance induced Safety Mode in the December 2024 advisory population

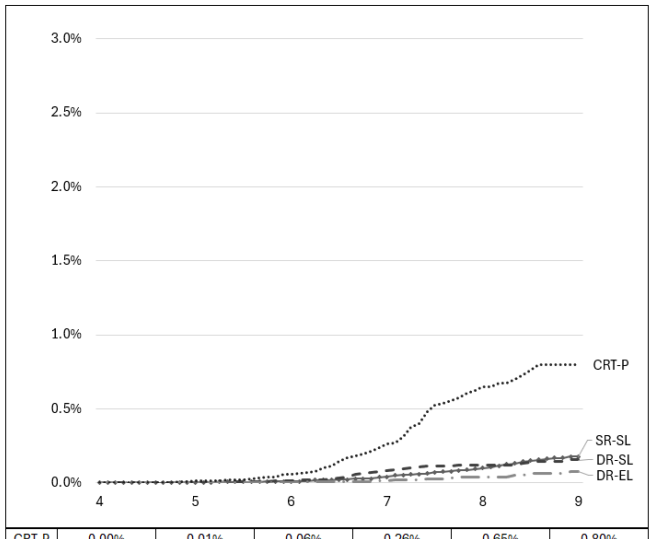
CRT-P	0.00%	0.01%	0.06%	0.26%	0.65%	0.80%
SR-SL	0.00%	0.01%	0.01%	0.04%	0.10%	0.18%
DR-SL	0.00%	0.00%	0.02%	0.08%	0.12%	0.16%
DR-EL	0.00%	0.00%	0.00%	0.02%	0.04%	0.08%

Figure 2 Occurrence rates for high battery impedance induced Safety Mode in remaining devices
